## Landslide repair in Km 11 CA-6 Highway using MSE walls

**Abstract.** During the winter of 2010, a landslide occurred at the km 11 of CA-6 Highway between the cities of Tegucigalpa and Danlí in Honduras. Because of excessive precipitation, landslides are common in countries with tropical weather like Honduras, producing the increase in pore water pressure inside the earth. The proposal of this document is to show the mechanism that caused the landslide and expose the solution adopted to repair and ensure a long time stability of the landslide. For reach this goal, a Mechanically Stabilized Earth wall (MSE wall) was constructed. The MSE walls have proven to be an efficient solution around the world to landslides stabilization. Moreover, in many cases, there are compressible soils that have poor quality behaviour doing the MSE walls a more suitable solution because of their flexible structure and good performance to differential and total settlements. This is the case of a tiered MSE wall constructed to repair the slope failure in the km 11 of the CA-6 highway. This wall is the highest MSE wall constructed in Honduras and consists of three-tier structures with a total height of 23

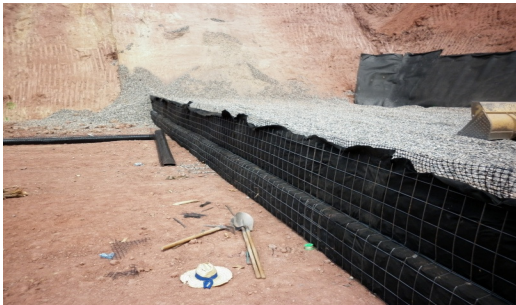
Welded wire mesh with biaxial geogrid and nonwoven geotextil. See fig. 3.

Figure 3. Facing type of the MSE wall

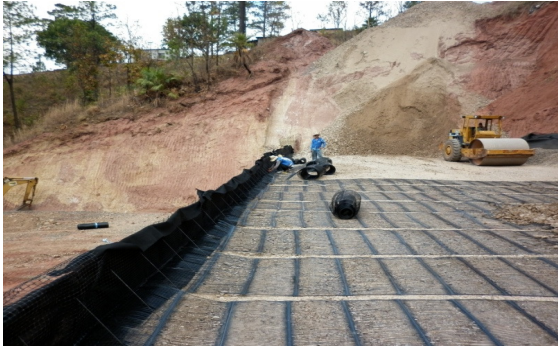
Figure 5. Construction of the first wall (2011)

The construction sequence of the MSE wall constructed at the km 11 of the CA-6 highway was: (See fig. 5, 6 and 7)

1. Preparation of subgrade.
2. Erection of the first row of facing line.

3. Construction of drainage blanket at the base and preparation of chimney's drains of gravel and geocomposite's drains behind the wall.
4. Placement of the first layer of reinforcement elements on the backfill.
5. Placement and compactation of the backfill over the reinforcing elements to the level of the next reinforcement layer (according to design).

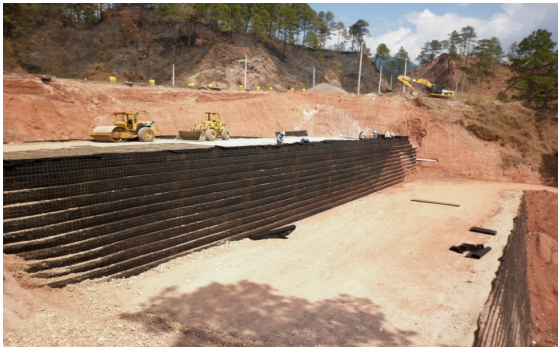
Figure 6. Construction of the second wall (2011)

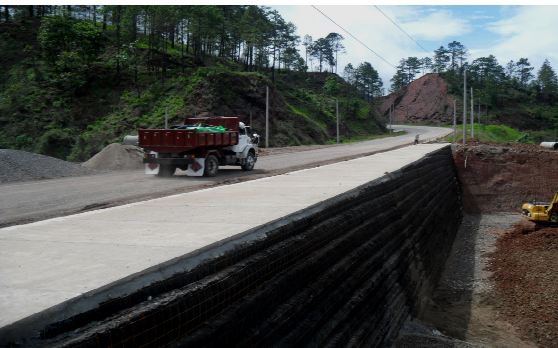
Figure 7. Construction of the third wall (2011)

6. Construction of superficial drainage and superficial protection plastic barriers to avoid runoff infiltration.
7. Enhancement of the drainage systems at the highway level.

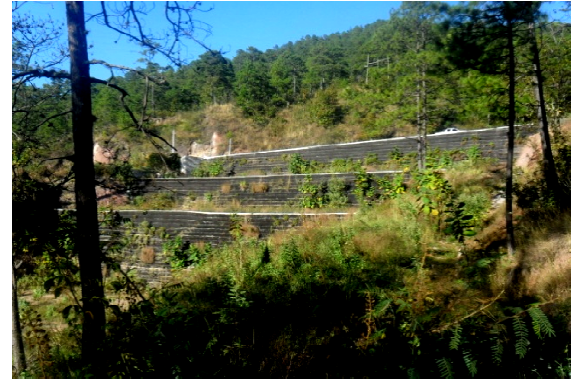
At this project, monitoring points or other control devices were not placed in field. But, at this moment (2013), no movements have been observed in this project that was constructed and finished two years ago. See project recent conditions at fig. 8

Figure 8. Panoramic 2013's view of the MSE wall constructed in the km 11 of the CA-6 highway
